CITY OF NEW ORLEANS

Historic District Landmarks Commission

Guidelines for Roofing

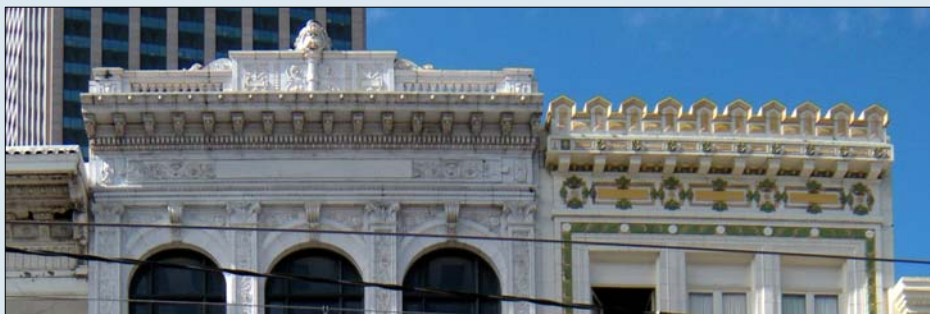
This commercial building row has decorative cornices and parapets at the front elevation with lower flat roofs behind. Retain all historic cornices and parapets.

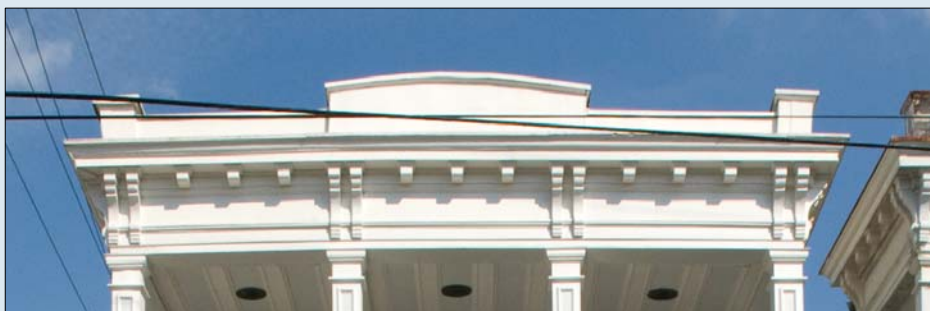
The parapet on this residential gallery features a central arch and conceals the low sloped gable roof beyond. The paired brackets at the cornice are typical of the Italianate style.

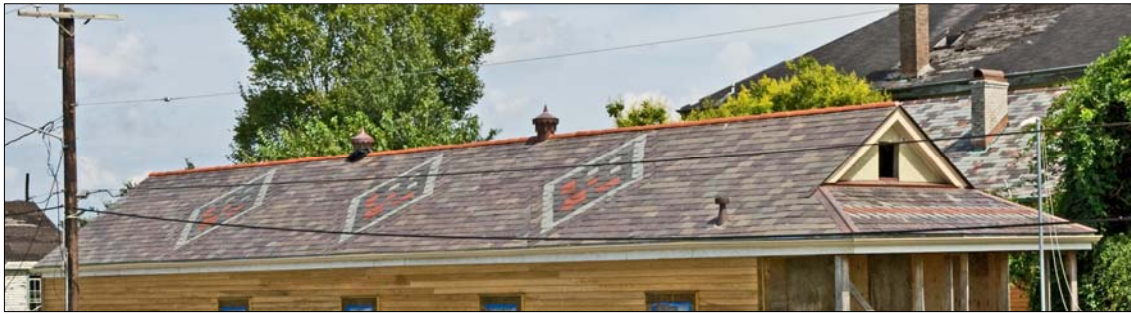
This distinctive slate roof with diamond patterns, terra cotta ridge caps, and Chinese caps are being retained as part of the rehabilitation project.

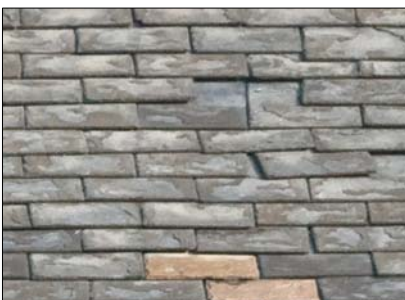
Individual missing or damaged slates can often be replaced, extending the serviceable life of the roof and postponing costly replacement.

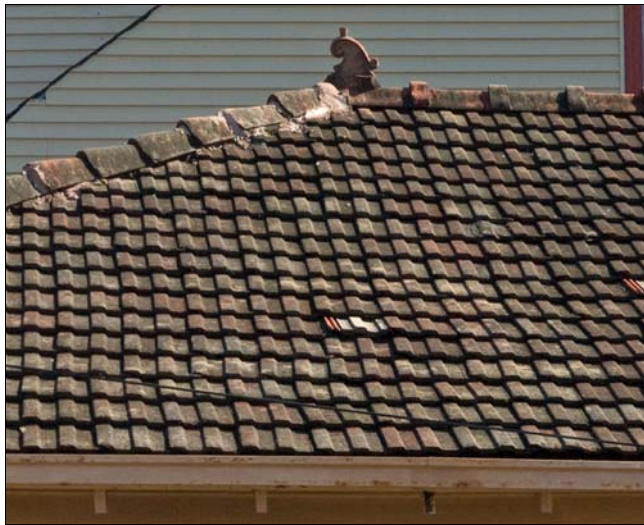
This concrete tile roof includes a finial and terra cotta ridge caps at the top of the main roof and along the roof hip.

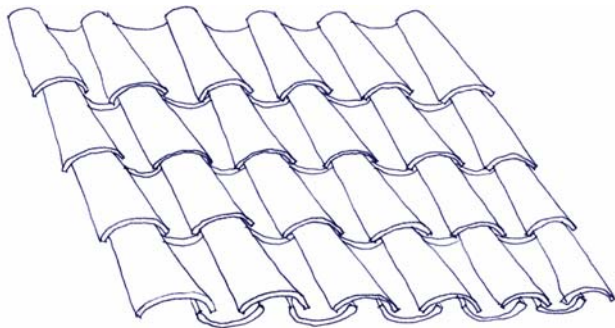
Terra cotta tile provides a durable, fire resistant and distinctive roof finish. Spanish tiles are rounded and installed in an overlapping pattern.

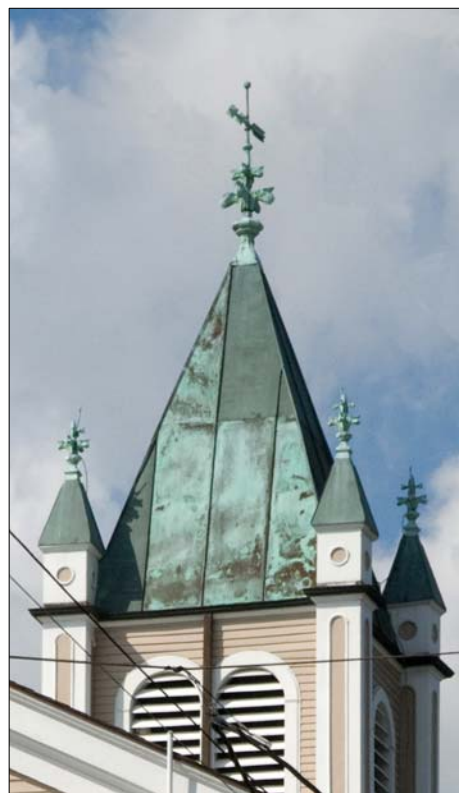
The top of this church tower includes a standing seam copper roof, copper finials and a weathervane. Copper roofing is known for its longevity with relatively little required maintenance.

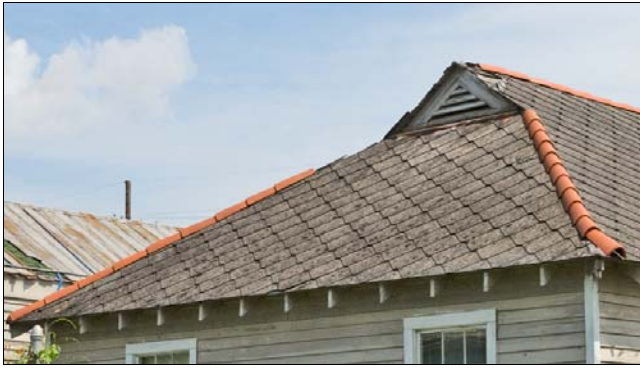
The asbestos shingle roof has terra cotta caps on the ridge and hips and a triangular louvered vent at the front gable. The ridge caps and louvered vents should be retained. Gutter installation is recommended.

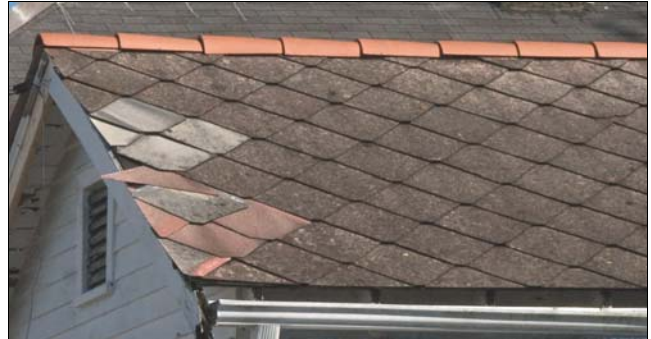
The asbestos roof has some non-asbestos replacement shingles of a similar size and shape as the existing roofing.

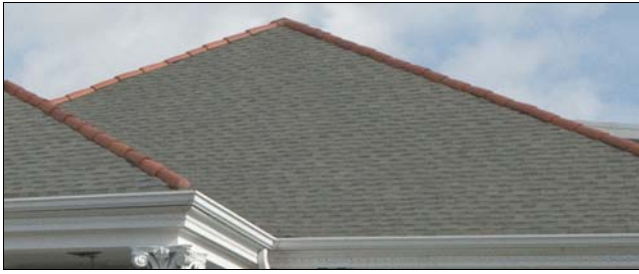
This dimensional asphalt shingle hipped roof features ridge tiles at the hips and a perimeter gutter.

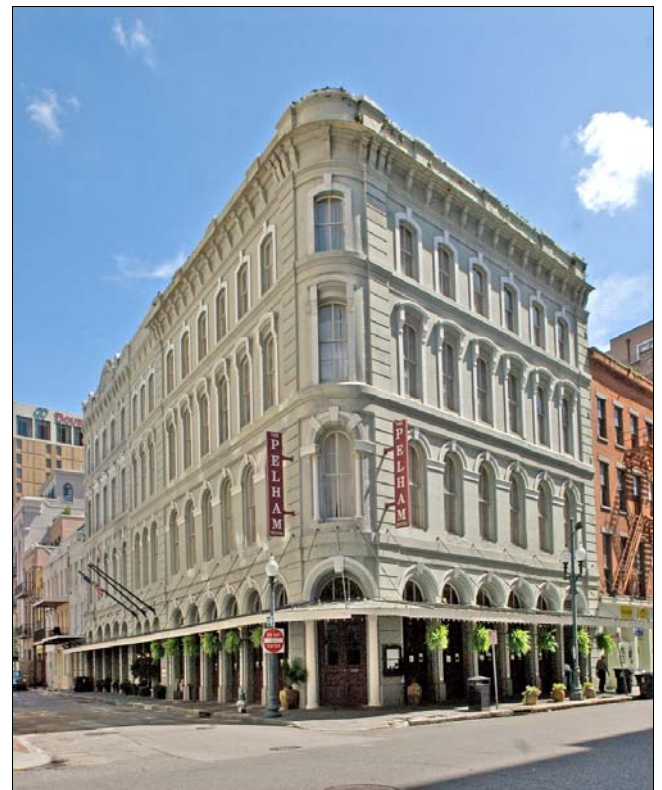
A flat or low-sloped roof is located behind the parapet and bracketed cornice.

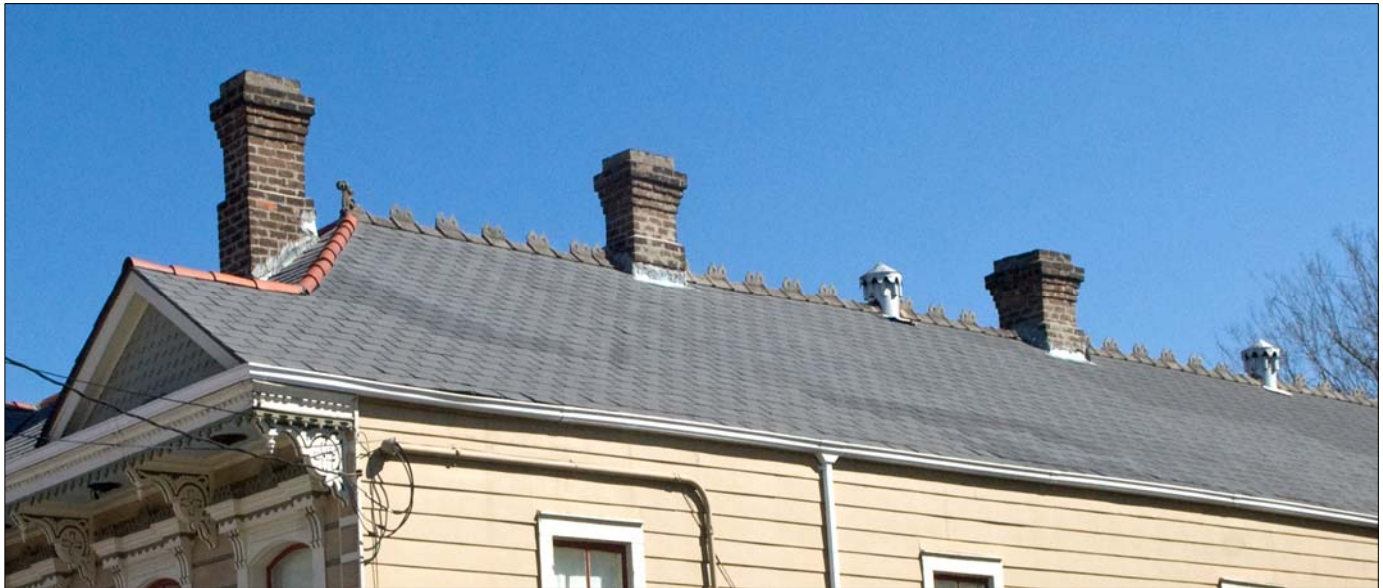
Ridge caps are located along the roof hips, cresting is along the top ridge and a finial is found at the end of the main roof gable. Chimney placement reflects the internal organization of the residence and Chinese caps provide roof ventilation.

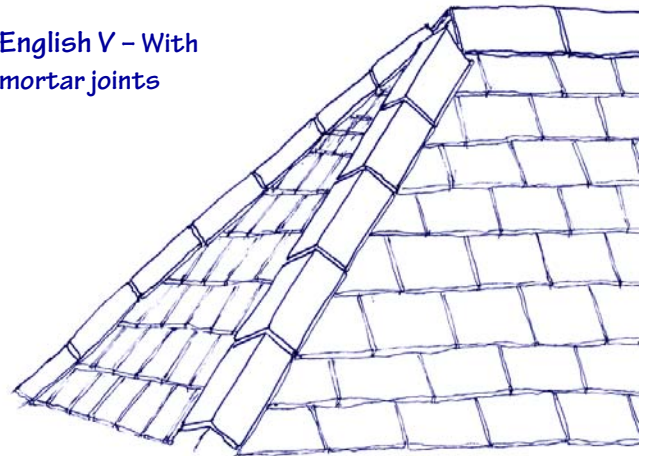
**English V – With
mortar joints**

Ridge tiles in New Orleans are often in an English-V profile with mortar between adjoining tiles as seen in the top drawing or in overlapping Spanish tiles as seen below.

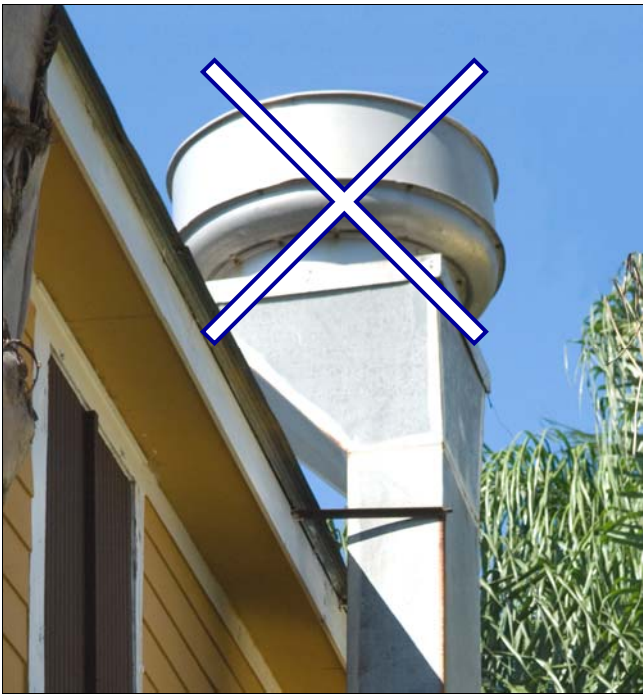
Restaurant vents and exhausts should be installed within the building envelope and in a location where they are not visible from the street.

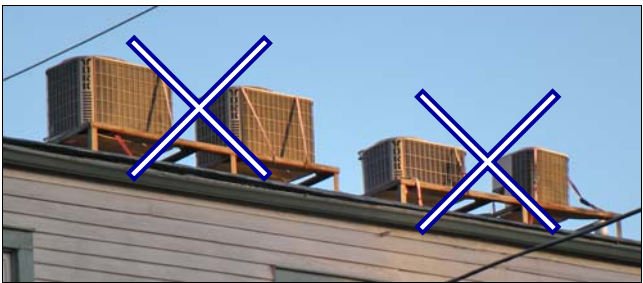
Rooftop mechanical equipment should not be visible from the street.

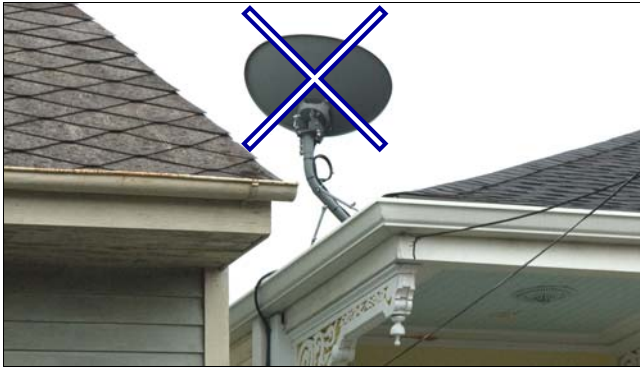
Satellite dishes should be installed towards the rear of the building so they are minimally visible from the street.

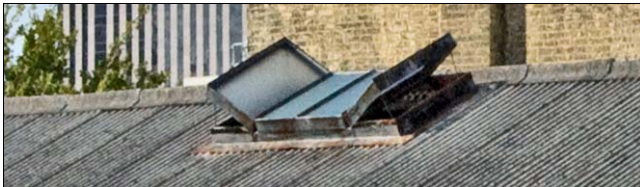
Some skylights were historically located in warehouse and commercial buildings, providing natural interior light and ventilation. The visibility of new skylights should be minimized.

Skylights are sometimes historically found in commercial buildings. They are occasionally appropriate in sloped roof building types and townhouses where dormer windows are not present. **Property owners are encouraged to select skylights that do not extend more than 8" above the roof surface; minimize the overall number; locate skylights a minimum of 10'-0" back from the front building wall, and 12" below the roof ridge, in unobtrusive locations, arranged in an orderly fashion.** The installation should minimize alteration of the roof structure with the long dimension oriented down the roof slope.

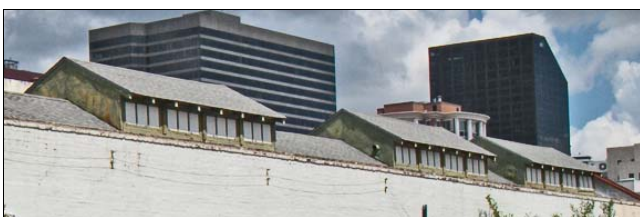
Roof monitors are more typically found on commercial buildings and often provide interior light and ventilation.

Roof monitors are structures that project up from the roof, used for ventilation with louvers, or for light or lookouts with windows. Monitors are often found on warehouse buildings. Property owners are encouraged to retain historic roof monitors.

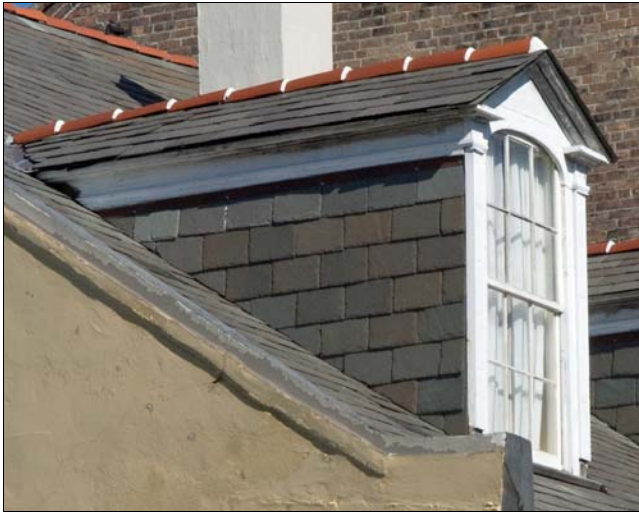
These gable roof dormers are appropriately located, proportioned and detailed for the building and include slate cheek walls. Spanish tile ridge caps should be retained.

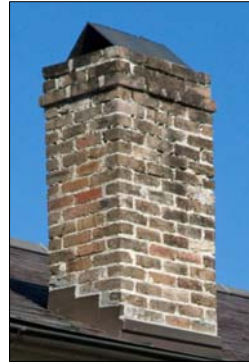
An inverted “V” cap is at the top of the chimney and flashing at its base.

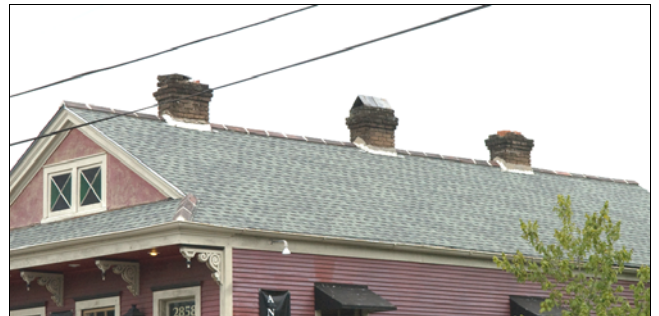
This row of three chimneys suggests the division of rooms on the interior of the building. The central chimney includes an inverted “V” cap and English V ridge tiles with mortared joints marking the top of the roof.
